Stucco

The Preservation and Repair of Historic Stucco

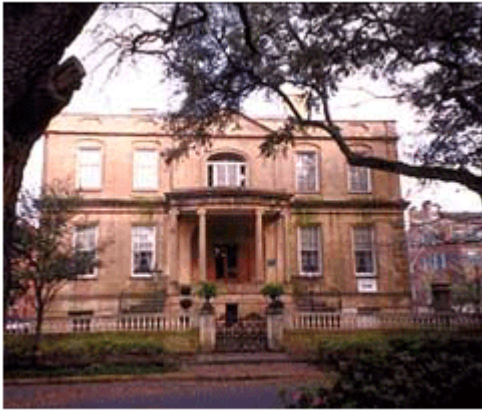
The stucco on the early-19th century Richardson-Owens-Thomas House in Savannah, Georgia, is a type of natural cement.

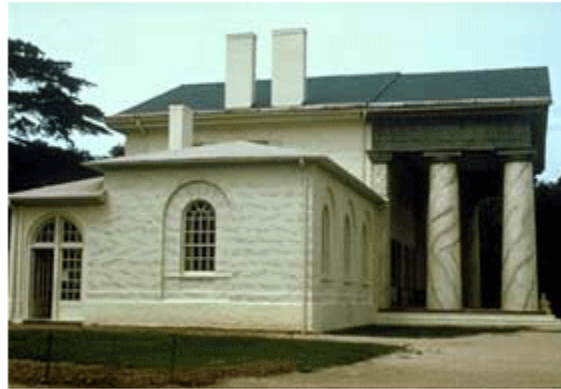
The stucco finish on Arlington House, Arlington, Virginia, was marbled in the 1

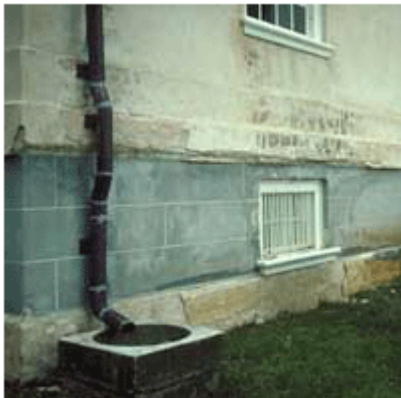
The damage to this stucco appears to be caused by moisture infiltration.

Most stucco deterioration is the result of water infiltration into the building's structure, either through the roof, around chimneys, window and door openings, or excessive ground water or moisture penetrating through, or splashing up from the foundation. Potential causes of deterioration include: ground settlement lintel and door frame settlement; inadequate and leaking gutters and downspouts; intrusive vegetation; moisture migration within walls due to interior condensation and humidity; vapor drive problems caused by furnace, bathroom and kitchen vents; and rising damp resulting from excessive ground water and poor drainage around the foundation. Water infiltration will cause wood lath to rot, and metal lath and nails to rust, which eventually will cause stucco to lose its bond and pull away from its substrate.

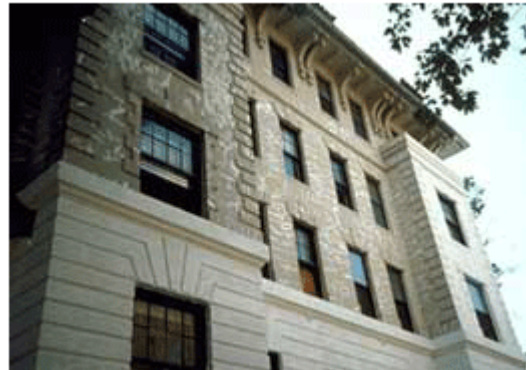
Caulking is not an appropriate method for repairing cracks in historic stucco.

Commercially available caulking compounds are not suitable materials for patching hairline cracks. Because their consistency and texture is unlike that of stucco, they tend to weather differently, and attract more dirt; as a result, repairs made with caulking compounds may be highly visible and unsightly. Larger cracks will have to be cut out in preparation for more extensive repair. Most stucco repairs will require the skill and expertise of a professional plasterer.

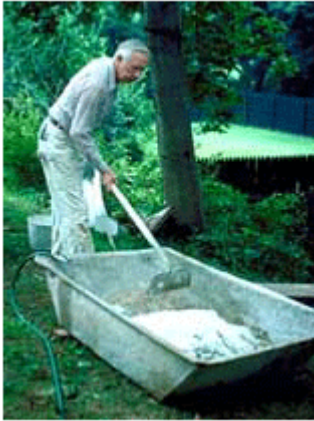
The dry materials must be mixed thoroughly before adding water to make the stucco.

- Stucco mortar should not be over-mixed. (Hand mix it for 10 to 15 minutes after adding water, or machine-mix for three to four minutes after all ingredients are in mixer.) Over-mixing can cause crazing and discoloration, especially in tinted mortars. Over-mixing will also tend to make the mortar set too fast, which will result in cracking and poor bonding or keying to the lath or masonry substrate.

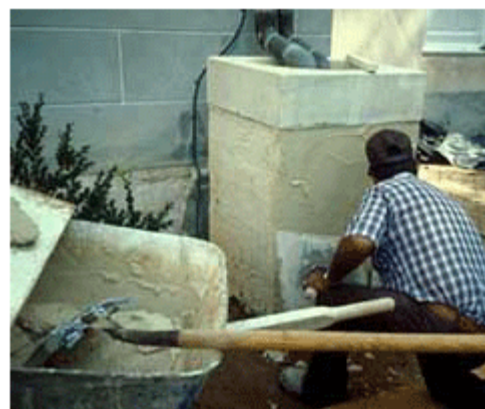
The deteriorated surface of this catch basin is being re-stuccoed.

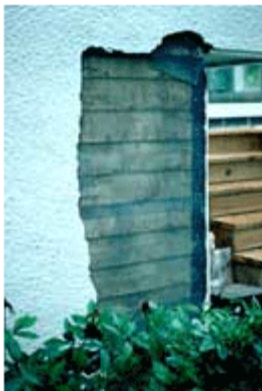
The stucco will be applied to the wire lath laid over the area to be patched.

To ensure a firm bond, the new patch must not overlap the old stucco. If the stucco has lost its bond or key from wood lath, or the lath has deteriorated or come loose from the substrate, a decision must be made whether to try to re-attach the old lath, to replace deteriorated lath with new wood lath, or to leave the historic wood lath in place and supplement it with modern expanded metal lath. Unless authenticity is important, it is generally preferable (and easier) to nail new metal lath over the old wood lath to support the patch. Metal lath that is no longer securely fastened to the substrate may be removed and replaced in kind, or left in place and supplemented with new wire lath.

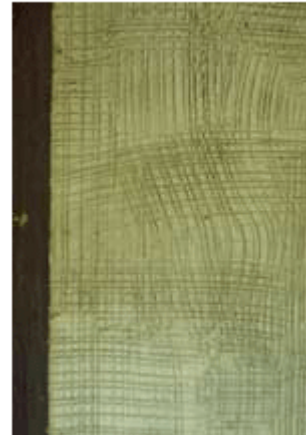
A stucco mix compatible with the historic stucco should be selected after analyzing the existing stucco.

The final finish coat will be applied to this scratch coat.

After thoroughly dampening the masonry or wood lath, the first scratch coat should be applied to the masonry substrate, or wood or metal lath, in a thickness that corresponds to the original (if extant), or generally about 1/4-inch to 3/8-inch. The scratch coat should be scratched or crosshatched with a comb to provide a key to hold the second coat. It usually takes 24 to 72 hours, and longer in cold weather, for each coat to dry before the next coat can be applied. The second coat should be about the same thickness as the first, and the total thickness of the first two coats should generally not exceed about 5/8-inch. This second or leveling coat should be roughened using a wood float with a nail protruding to provide a key for the final or finish coat. The finish coat, about 1/4-inch thick, is applied after the previous coat has initially set. If this is not feasible, the base coat should be thoroughly dampened when the finish coat is applied later. The finish coat should be worked to match the texture of the original stucco.

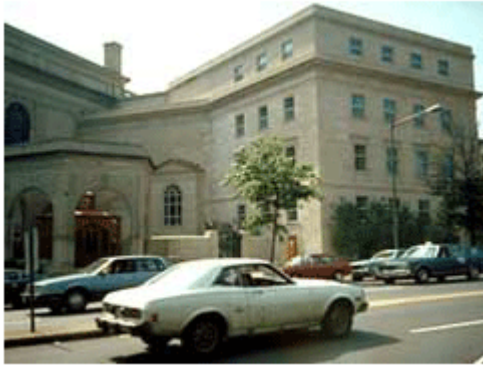
The new addition on the right is stucco scored to imitate the limestone of the historic building on the left.

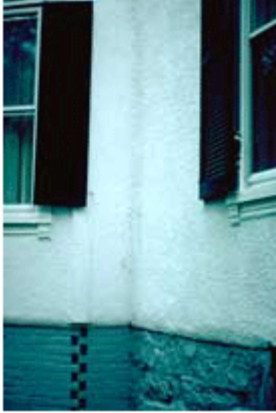
This stucco house has a rough cast finish.

The most common early 20th-century stucco finishes are often found on bungalow-style houses, and include: spatter or spatterdash (sometimes called roughcast, harling or wetdash), and pebble-dash or drydash. The spatterdash finish is applied by throwing the stucco mortar against the wall using a whisk broom or a stiff fiber brush, and it requires considerable skill on the part of the plasterer to achieve a consistently rough wall surface. The mortar used to obtain this texture is usually composed simply of a regular sand, lime and cement mortar, although it may sometimes contain small pebbles or crushed stone aggregate, which replaces half the normal sand content. The pebble-dash or drydash finish is accomplished manually by the plasterer throwing or "dashing" dry pebbles (about 1/8-inch to 1/4-inch in size) onto a coat of stucco freshly applied by another plasterer. The pebbles must be thrown at the wall with a scoop with sufficient force and skill that they will stick to the stuccoed wall. A more even or uniform surface can be achieved by patting the stones down with a wooden float. This finish may also be created using a texturing machine.
